Understanding Earthquake Risk in Thailand: Reflections on the 28 March 2025 Earthquake

Pennung Warnitchai

Professor of Structural Engineering
Asian Institute of Technology (AIT)

Director of Earthquake Research
Center of Thailand (EARTH)

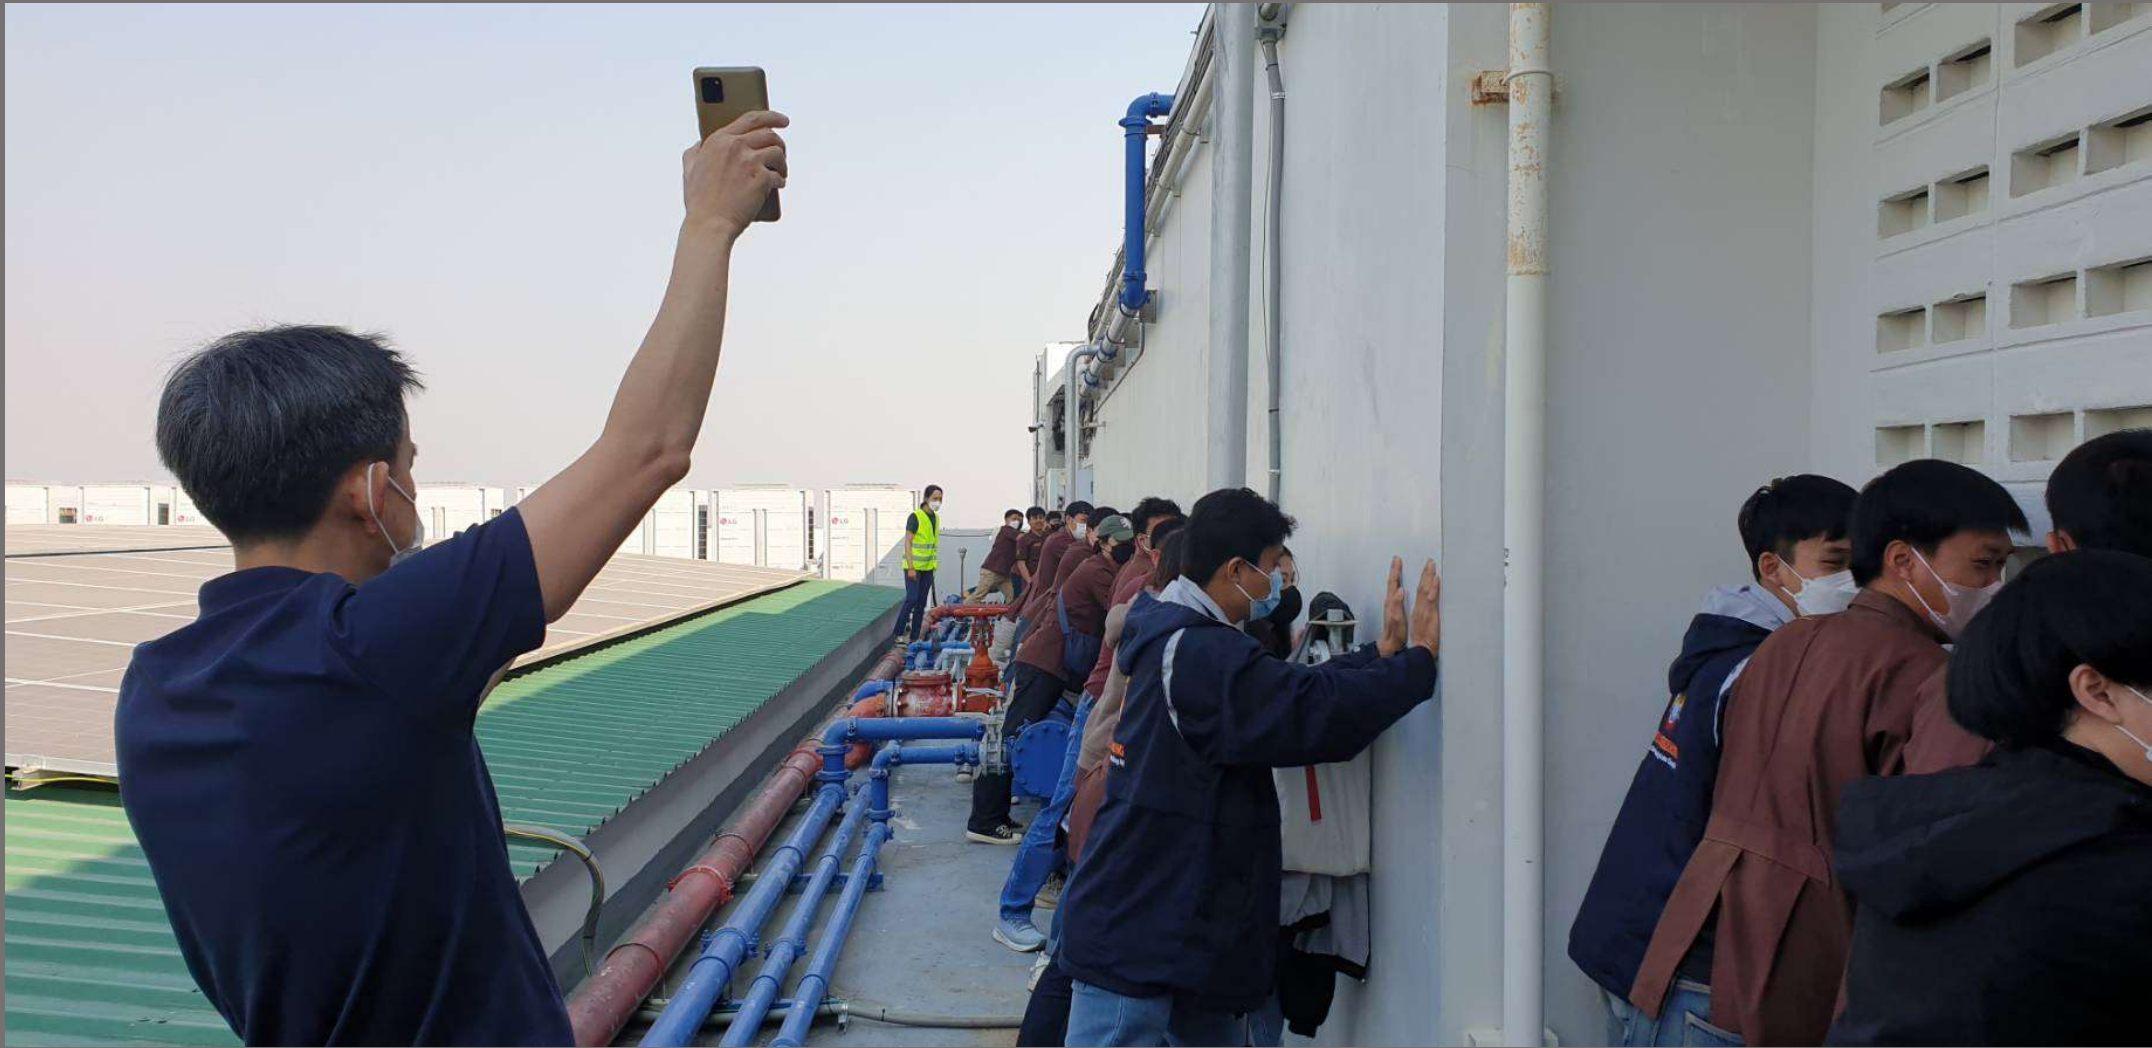
Testing the SHM system & Identify Building Dynamic Properties by Human Excitation

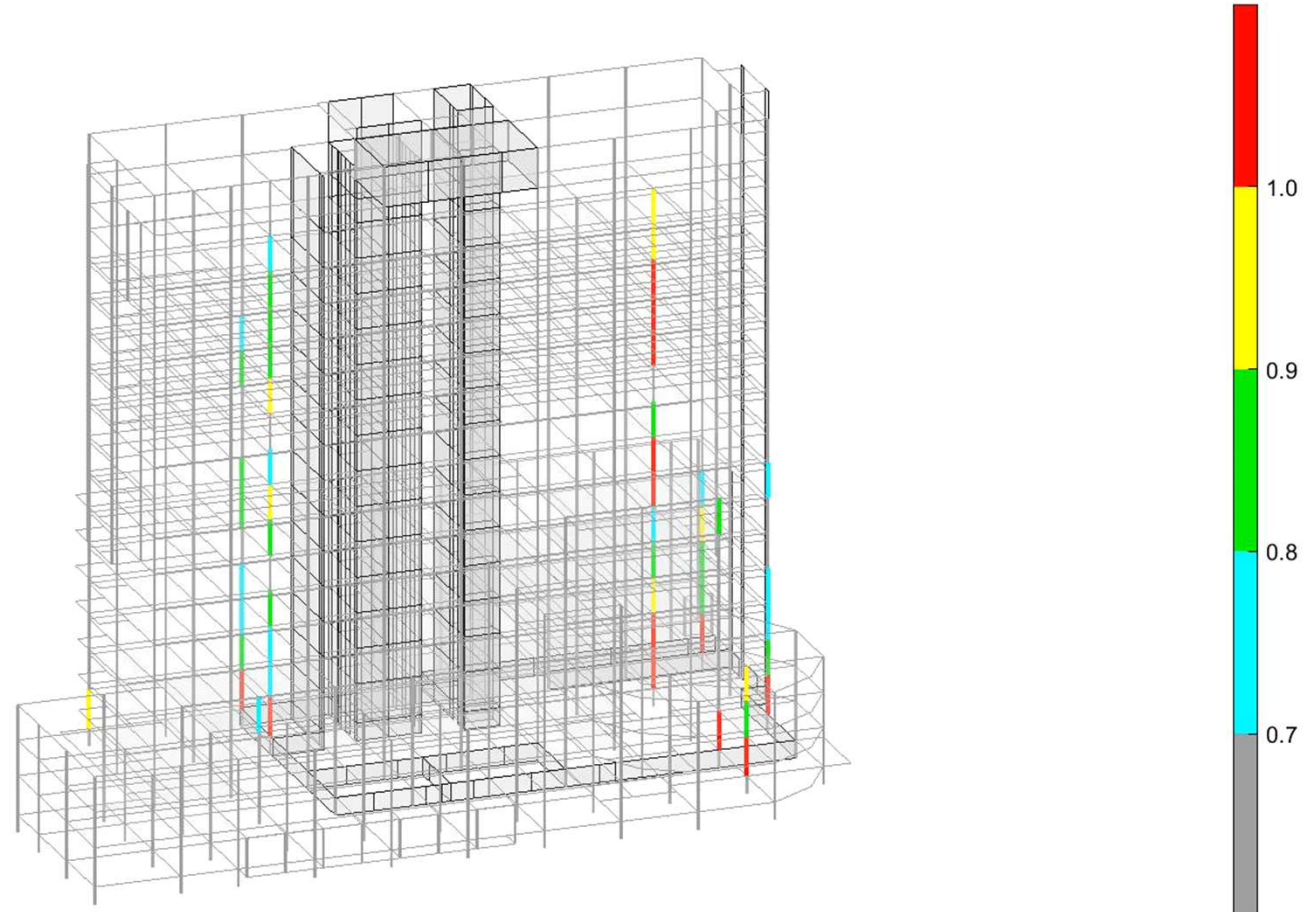
Column PMM D/C Ratio
